**DEPARTMENT OF TRANSPORTATION**

Contract #: 04-0120F4Cty: SF/ALA Rte: 80 PM: 13.2/13.9File #: 69.28**WELDING INSPECTION REPORT****Resident Engineer:**Siegenthaler, Peter**Address:** 333 Burma Road**City:** Oakland, CA 94607**Report No:** WIR-024224**Date Inspected:** 01-Jun-2011**Project Name:** SAS Superstructure**OSM Arrival Time:** 1900**Prime Contractor:** American Bridge/Fluor Enterprises, a JV**OSM Departure Time:** 700**Contractor:** Zhenhua Port Machinery Company, Ltd (ZPMC), Changxing Island **Location:** Shanghai, China**CWI Name:** See below**CWI Present:** Yes No**Inspected CWI report:** Yes No N/A**Rod Oven in Use:** Yes No N/A**Electrode to specification:** Yes No N/A**Weld Procedures Followed:** Yes No N/A**Qualified Welders:** Yes No N/A**Verified Joint Fit-up:** Yes No N/A**Approved Drawings:** Yes No N/A**Approved WPS:** Yes No N/A**Delayed / Cancelled:** Yes No N/A**Bridge No:** 34-0006**Component:** OBG**Summary of Items Observed:**

## WELDING INSPECTION REPORT

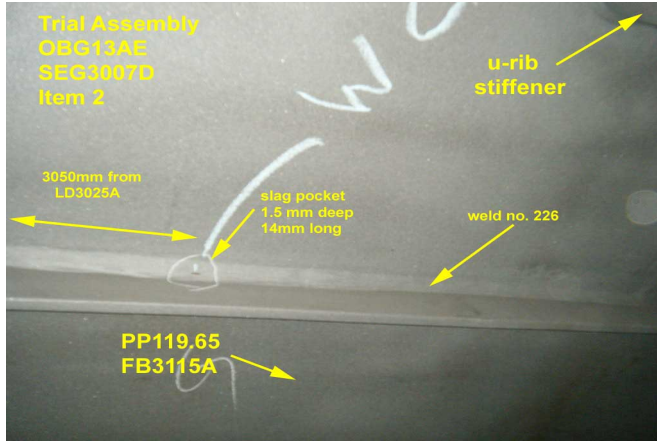
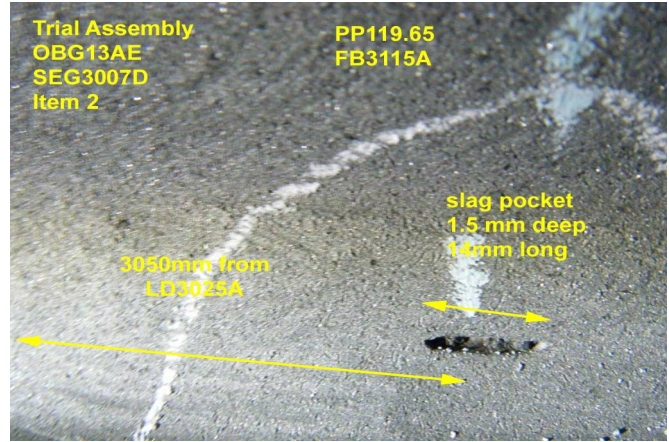
This Caltrans QA Inspector performed a pre-blast visual inspection in OBG13AE. This inspection included the bottom surface of Deck Plates DP3073, DP3074, DP3075, DP3076, and approximately 1500mm of the top sides of all Floor Beams and Diaphragms between Panel Point 119 + 1500 through 120 and Longitudinal Diaphragm LD3025A through Longitudinal Bulkhead SA3093A. Surface defects and base metal surface irregularities that required grinding were marked up with colored chalk, and weld defects that require welding were taped with gray masking tape for repair after the coating has been applied. ZPMC QC and ABF inspection personnel were present during the inspection and informed of QA findings. (see photos)
